SECTION 32 PROGRAM.  
STREAMBANK EROSION CONTROL  
EVALUATION AND DEMONSTRATION  
WORK UNIT 4-RESEARCH ON SOIL STABILITY  
AND IDENTIFICATION OF CAUSES OF  
STREAMBANK EROSION.  
EVALUATION OF SPRAY-ON STABILIZERS FOR  
BANK PROTECTION,

Jessie C. Oldham

February 1979

Investigation Report I

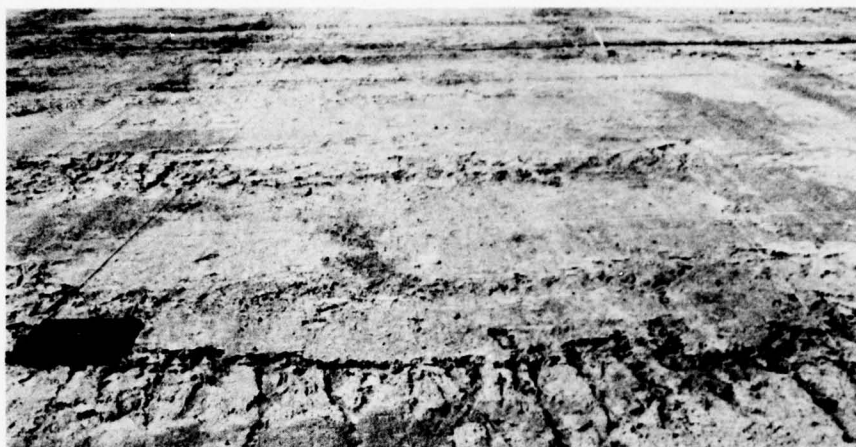
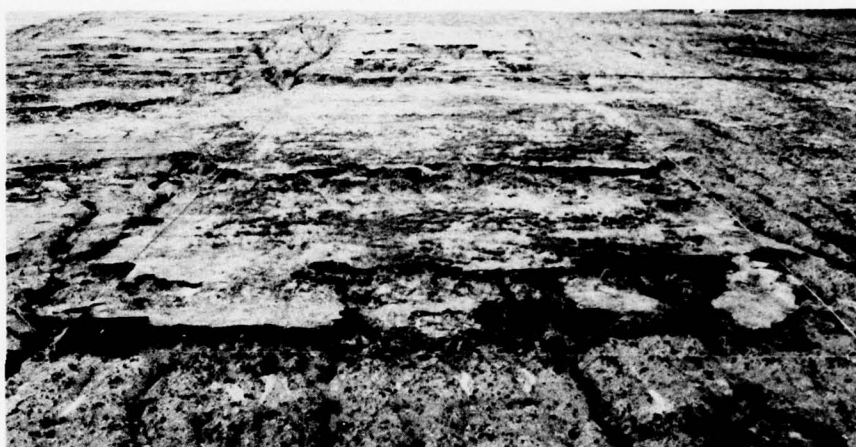
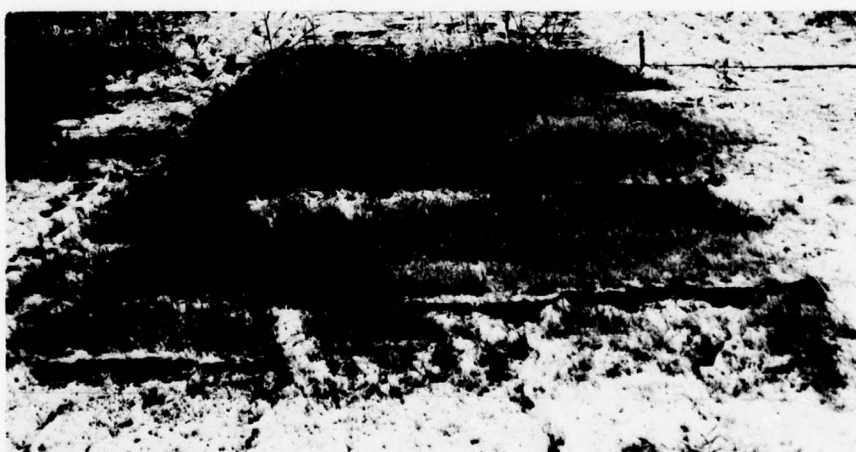
Figure 8. Application of Aerospray-70 at rate of  $0.122 \text{ l/m}^2$  (130 gal/acre) on the slope (Section F<sub>2</sub>)

8. Aerospray-70 was applied on the slope at rates of 0.122 and 0.183  $\ell/m^2$  (130 and 195 gal/acre). The two plots are shown in Figures 8 and 9, respectively. Examination of the photographs taken on 11 May reveal that rills of 10 to 20 cm (4 to 8 in.) had formed outside the test plots. Sloughing was apparent in both plots, but no rills had formed in the plots. The 11 May photographs also reveal that plant emergence is greater in the plot having the lighter application. This deficiency was only temporary as noted in photographs taken on 22 June. At this time, plant emergence and growth rate were approximately equal in both plots. These sections appeared to be equally effective in controlling erosion.

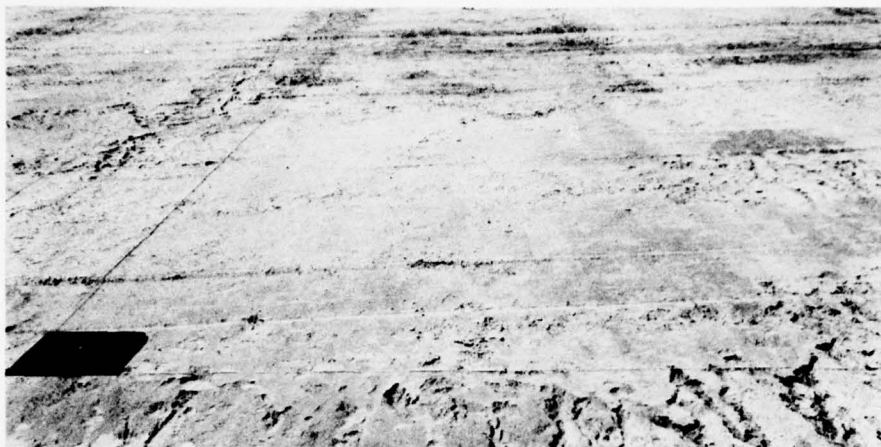
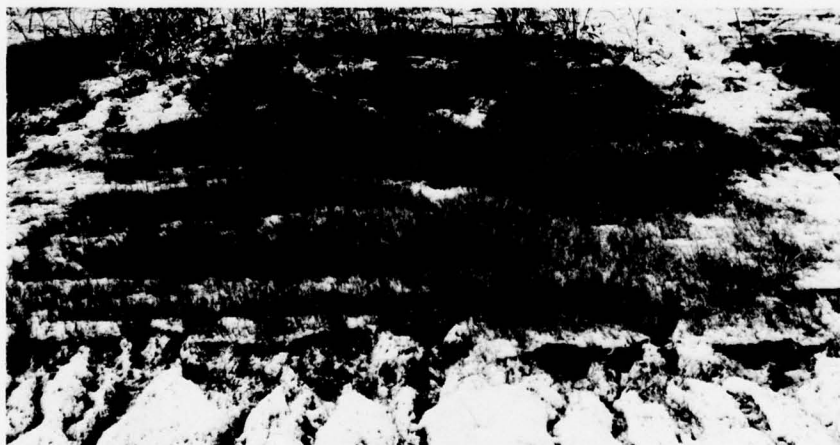
Figure 9. Application of Aerospray-70 at rate of  $0.183 \text{ l/m}^2$  (195 gal/acre) on the slope (Section G<sub>2</sub>)

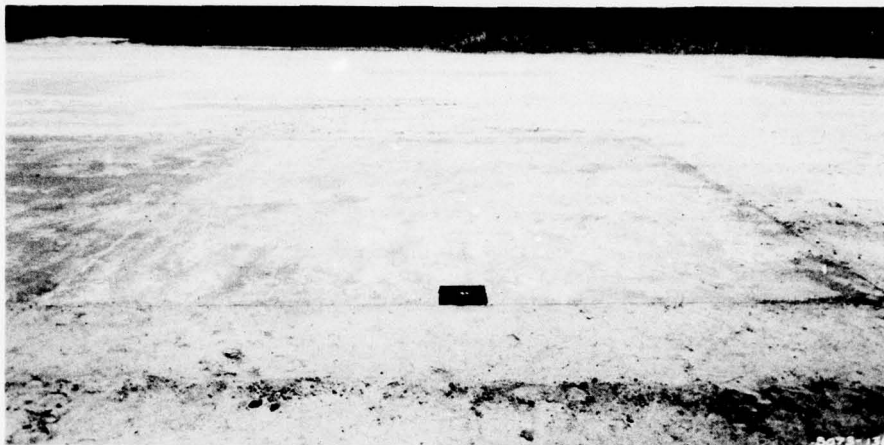
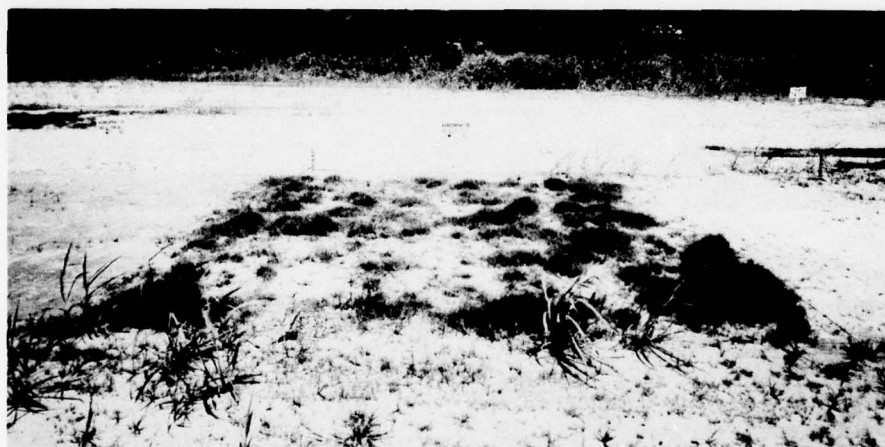
Figure 10. Application Aerospray-70 at rate of  
 $0.122 \text{ l/m}^2$  (130 gal/acre) on the flat area (Section B<sub>3</sub>)

9. Plant emergence and growth rate using Aerospray-70 at 0.122  $\ell/m^2$  (130 gal/acre) in the flat area were poor (Figure 10) but better than in the control plot. Plant emergence and growth rate were poorer for all plots on the flat area than for those located on the slope. This may be due to the difference in nutrients in the soil. No other conclusions could be drawn.

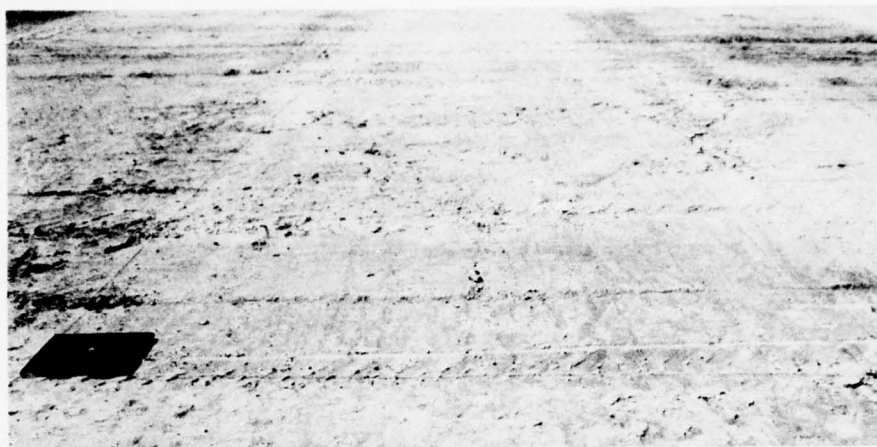
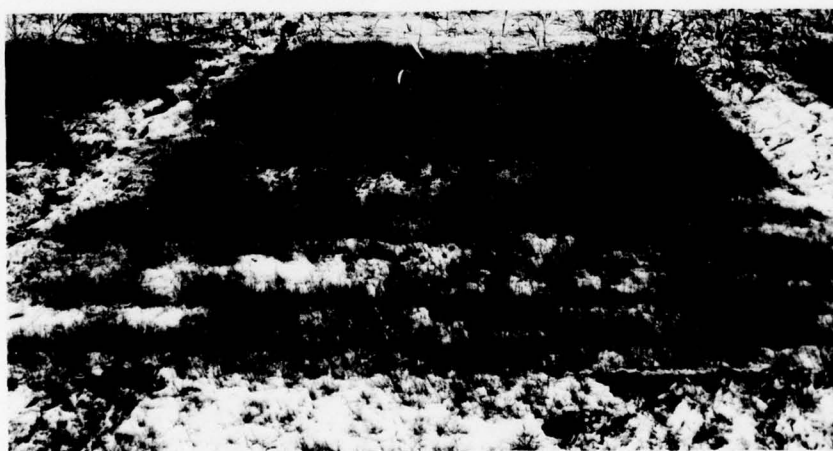
Figure 11. Application of Soil Seal at rate of  $0.041 \text{ l/m}^2$  (45 gal/acre) on the slope (Section H<sub>2</sub>)

10. Soil Seal was applied at rates of 0.041 and 0.061  $\ell/m^2$  (45.0 and 67.5 gal/acre). The two plots on the slope are shown in Figures 11 and 12, respectively. Plant emergence was good but slow. Once the plants had emerged, growth rate was good. The growth rate was greater in the plot having the greater application rate. In the flat area, the plot stabilized with Soil Seal (Figure 13) had very poor plant emergence and plant growth. Soil Seal appears to be a very effective stabilizer. Very little erosion took place within the plot while the area outside the plots was badly eroded.

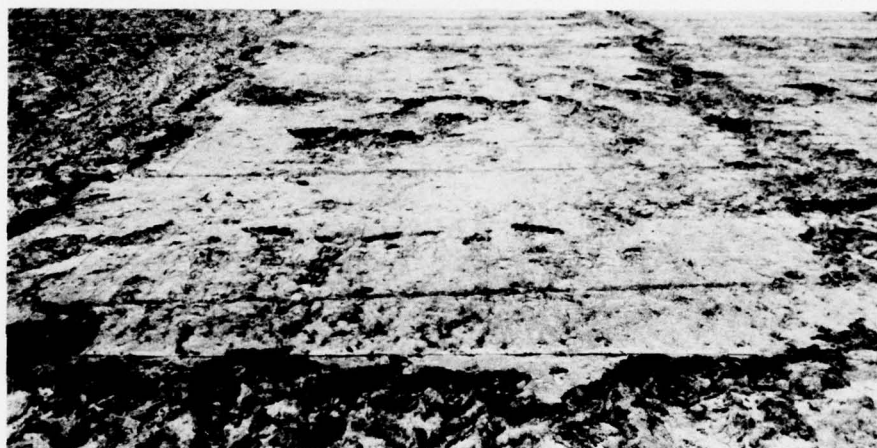
Figure 12. Application of Soil Seal at rate of  $0.061 \text{ l/m}^2$  (67.5 gal/acre) on the slope (Section I<sub>2</sub>)

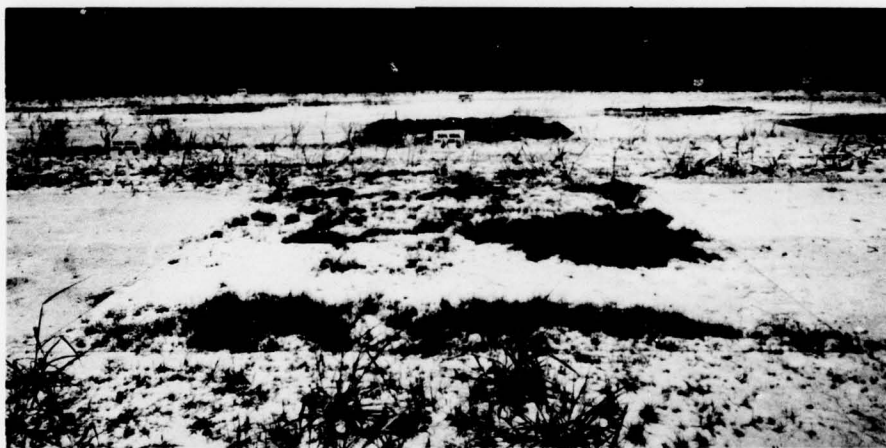
Figure 13. Application Soil Seal at rate of  
 $0.041 \text{ l/m}^2$  (45 gal/acre) on the flat area (Section C<sub>3</sub>)

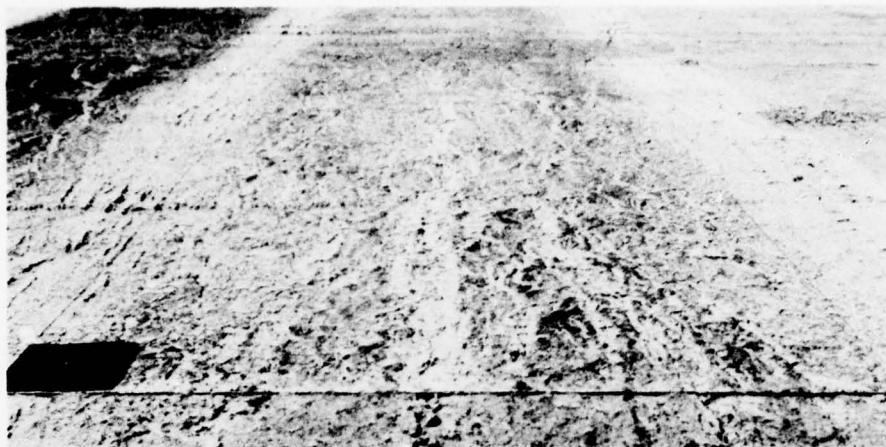
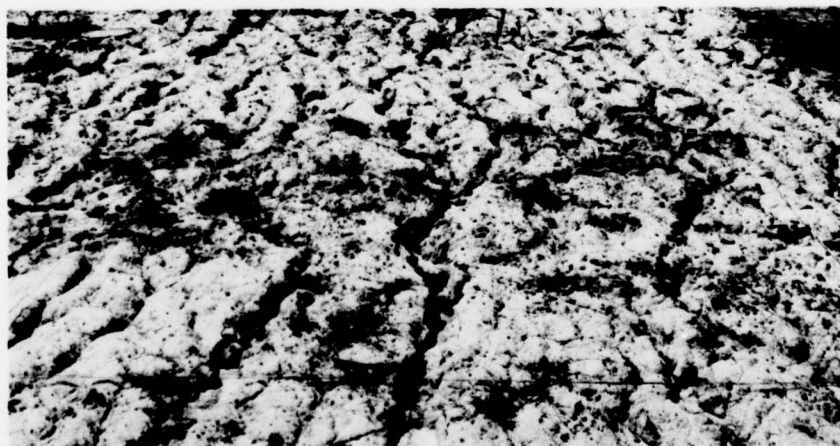
Figure 14. Application of Nerozin at rate of  $0.297 \text{ l/m}^2$  (320 gal/acre) on the slope (Section J<sub>2</sub>)

11. Nerozin was applied at the recommended rate of  $0.297 \text{ l/m}^2$  (320 gal/acre) and also at 1-1/2 times that rate or  $0.448 \text{ l/m}^2$  (490 gal/acre). Figures 14 and 15 show these plots as they appeared throughout the observation period. Neither plot on the slope was effective in maintaining stability of the soil particles to allow vegetation to be established. This may be due in part to the small quantity of the undiluted material recommended to cover the test plot. Also little or no benefit was realized when the recommended application rate was increased by 1-1/2 times. Total uniform coverage of the plot was difficult to achieve at these application rates. Photographs taken on 11 May reveal 10- to 20-cm (4- to 8-in.) rills and very little established vegetation in either plot. Very few Bermuda grass seeds germinated in the Nerozin plot on the flat (Figure 16). Most of the vegetation shown in Figure 16 is volunteer vegetation.

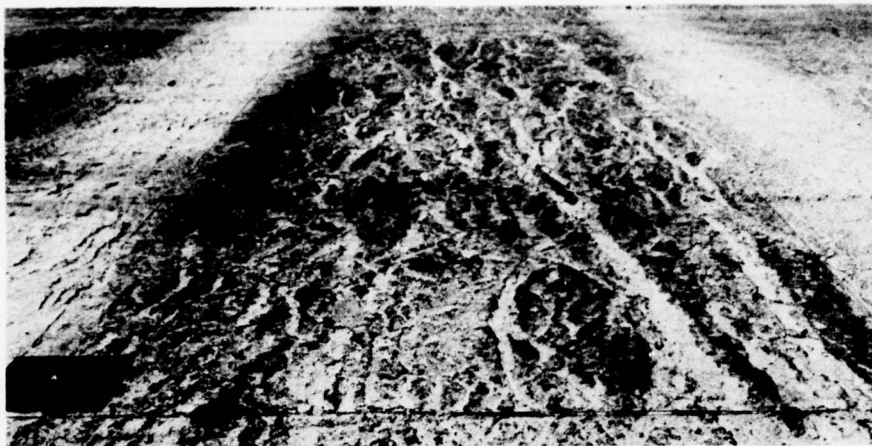
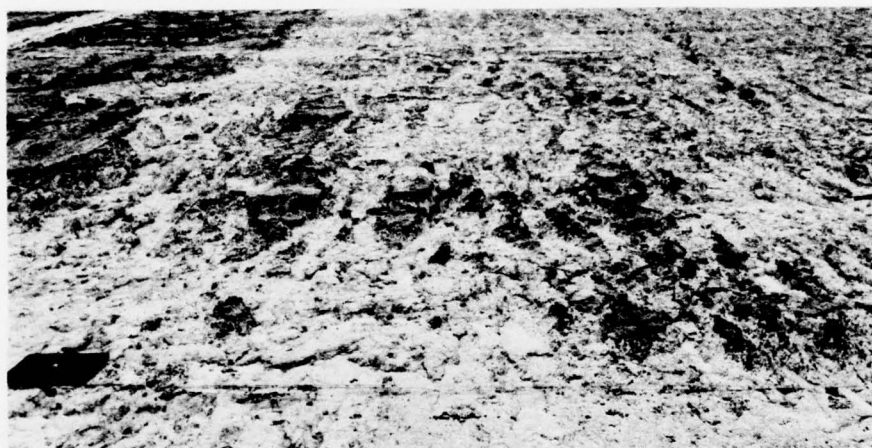
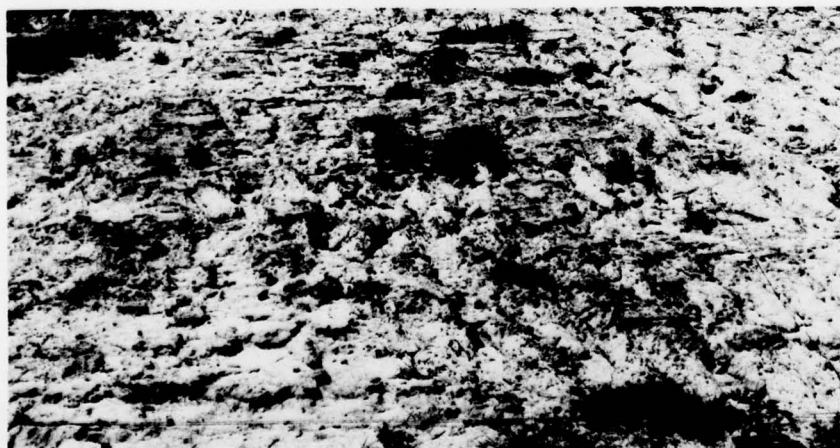
Figure 15. Application of Nerozin at rate of  $0.448 \text{ g/m}^2$  (480 gal/acre) on the slope (Section  $K_2$ )

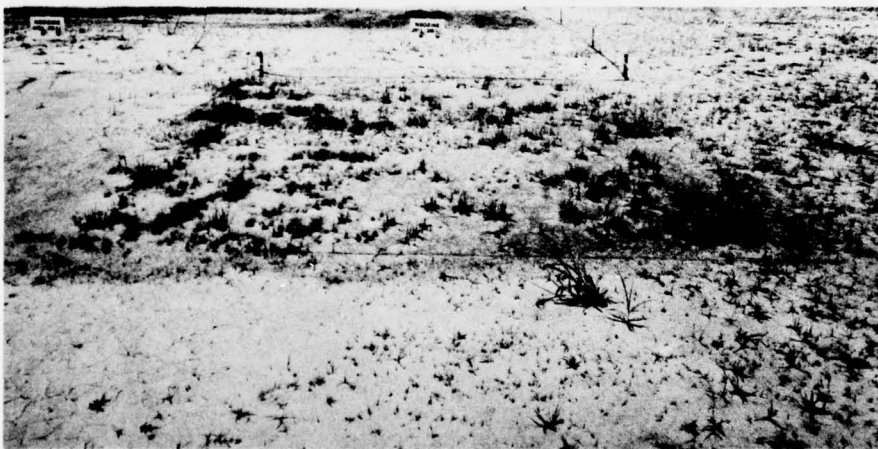
Figure 16. Application of Nerozin at rate of  $0.297 \text{ l/m}^2$  (320 gal/acre) on the flat area (Section E<sub>3</sub>)

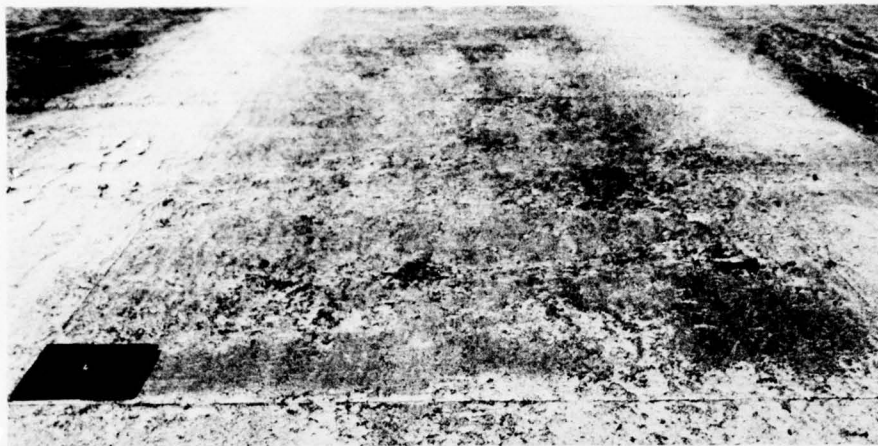
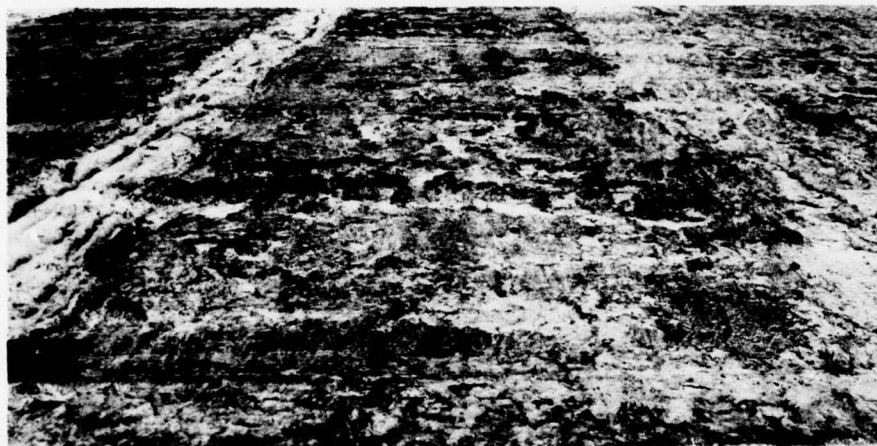
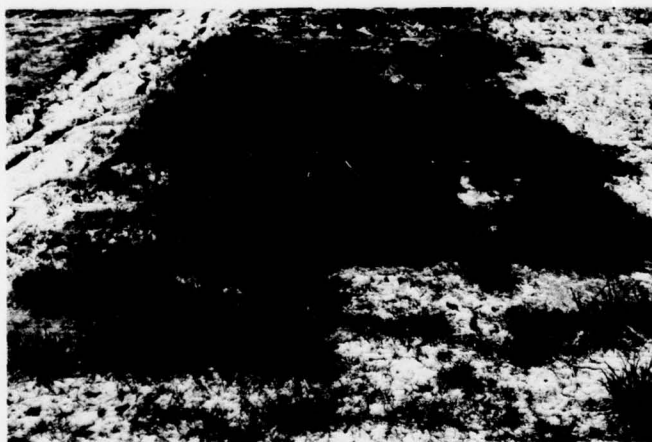
Figure 17. Application of Penepime at rate of  $0.896 \text{ l/m}^2$  (958 gal/acre) on the slope (Section  $L_2$ )

12. Peneprime was applied at rates of 0.896 and  $1.344 \text{ l/m}^2$  (958 and 1437 gal/acre). The two plots on the slope are shown in Figures 17 and 18, respectively. Plant emergence was slow in both plots and lighter in the plot having the heavier application rate. This light emergence also took place in the plot located in the flat area (Figure 19). This may be due to the hard crust formed by the heavy application of the undiluted material. Plants that did emerge appeared to have a fair growth rate. Erosion in the form of sloughing took place in both plots on the slope but appeared to be greater in the plot having the heavier application ( $1.344 \text{ l/m}^2$  (1437 gal/acre)).

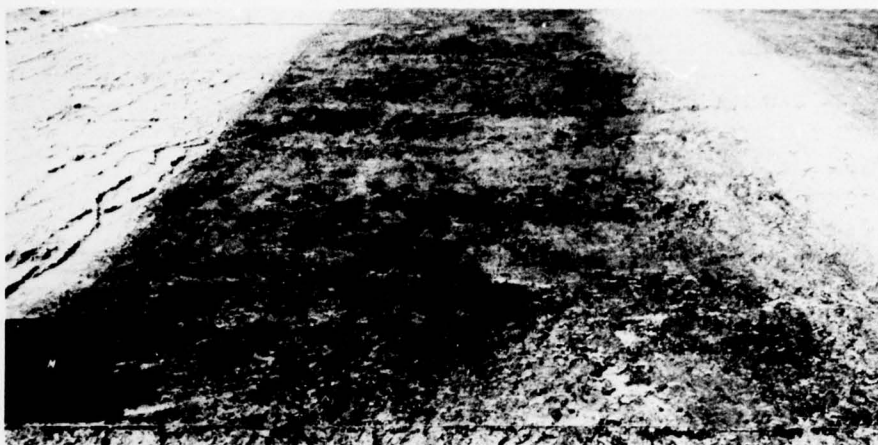
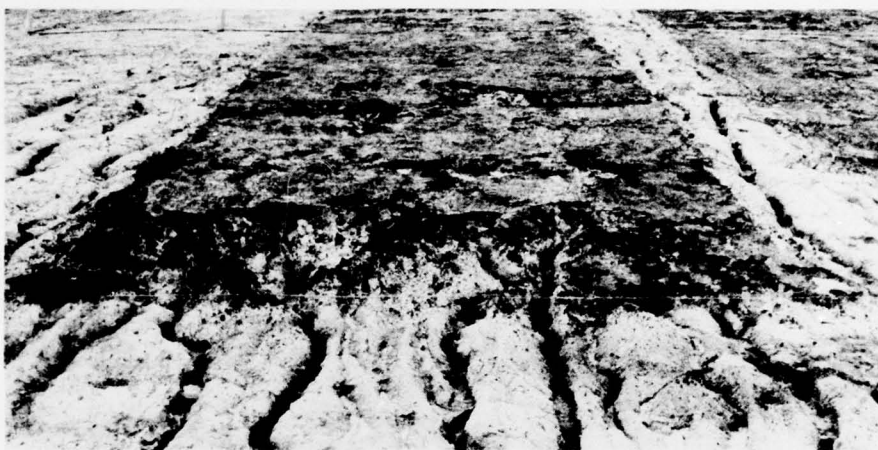
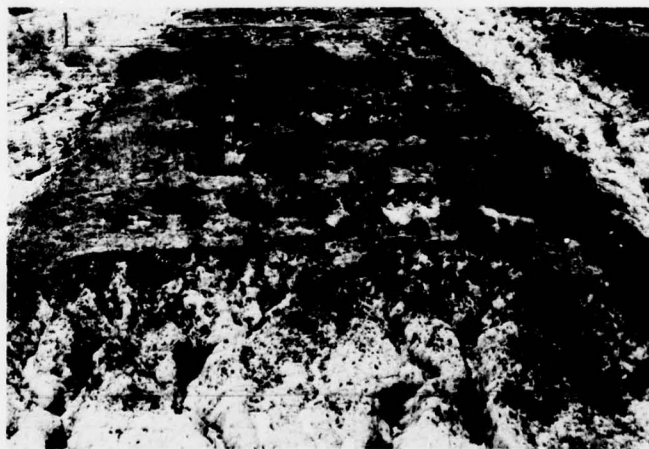
Figure 18. Application of Peneprime at rate of  $1.344 \text{ l/m}^2$  (1437 gal/acre) on the slope (Section M<sub>2</sub>)

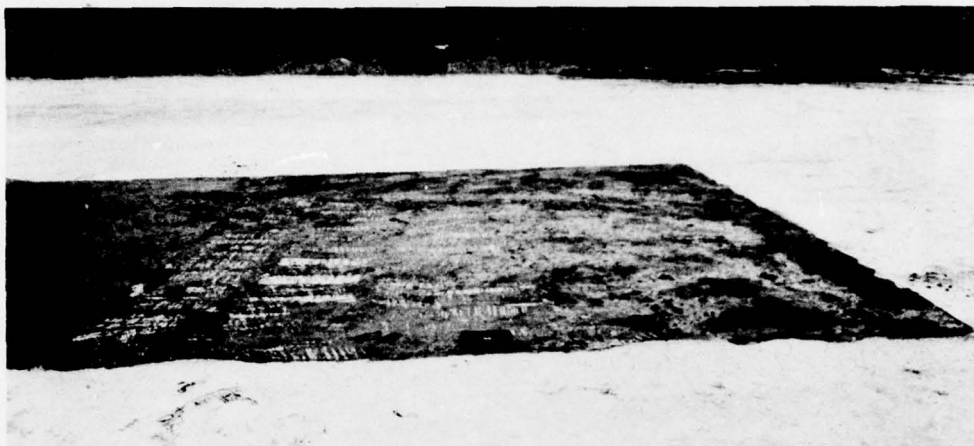
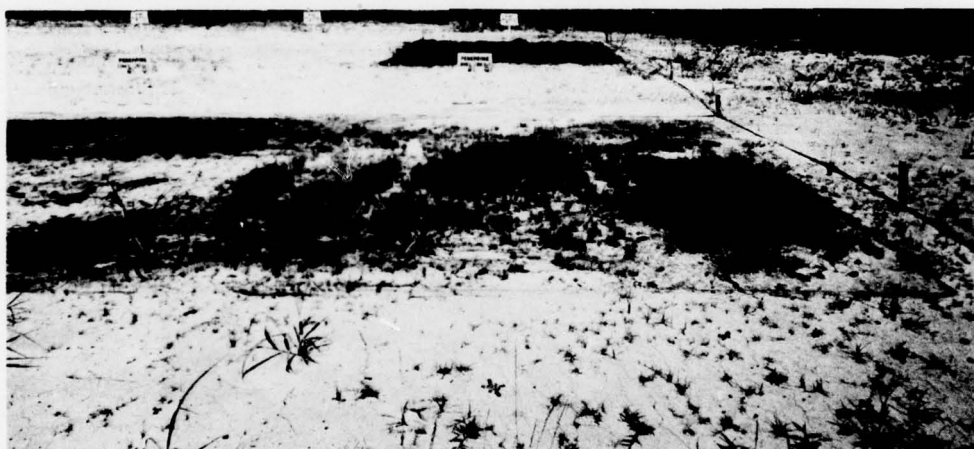
Figure 19. Application of Penepime at rate of  $0.896 \text{ l/m}^2$  (958 gal/acre) on the flat area (Section D<sub>3</sub>)

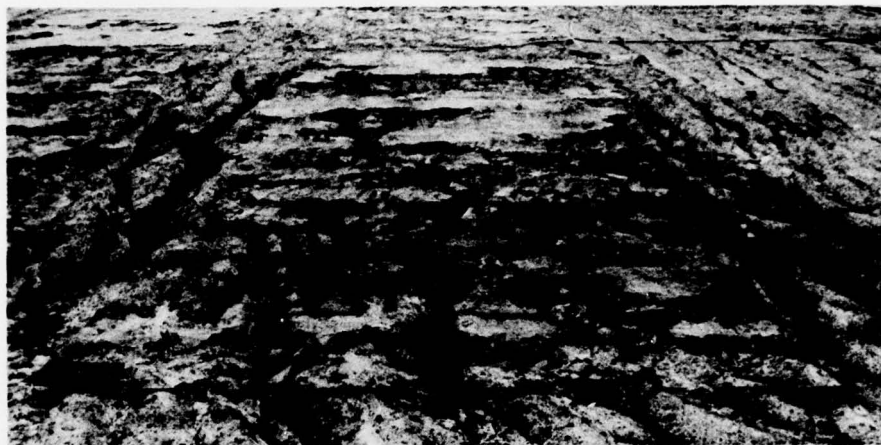
Figure 20. Application of DLR at rate of  
 $0.041 \text{ l/m}^2$  (45 gal/acre) on the slope (Section N<sub>2</sub>)

13. DLR was applied at rates of 0.041 and  $0.061 \text{ l/m}^2$  (45.0 and 67.5 gal/acre). Figures 20 and 21, respectively, show these plots

during the observation period. Plant emergence and growth rate were good in all plots including the plots in the flat area (Figure 22). Plots on the slope sustained a high degree of erosion. Rills of 15 to 20 cm (6 to 8 in.) formed in the plots, and sloughing was very evident.

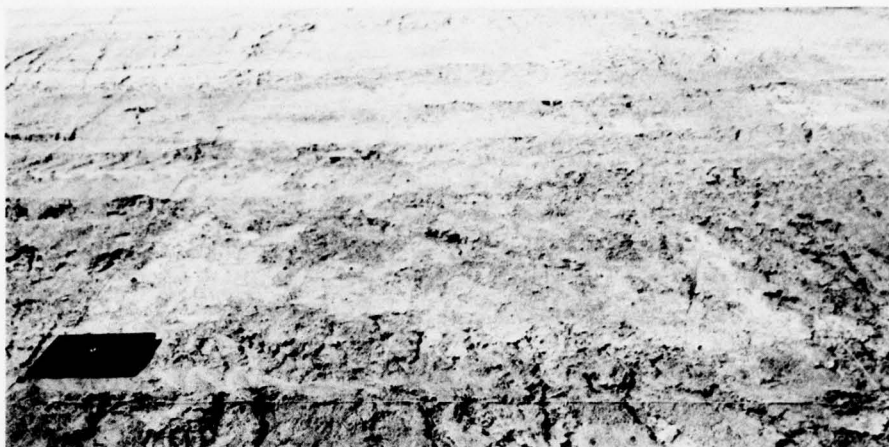
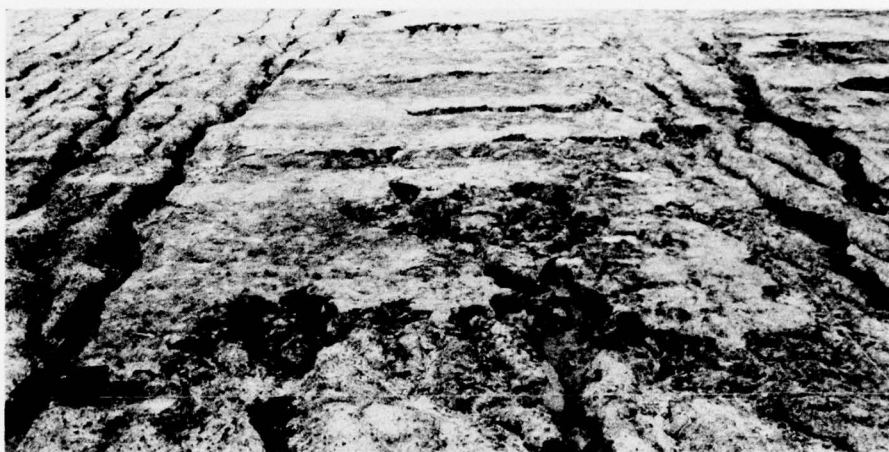
Figure 21. Application of DLR at rate of  $0.061 \text{ l/m}^2$  (67.5 gal/acre) on the slope (Section 0<sub>2</sub>)

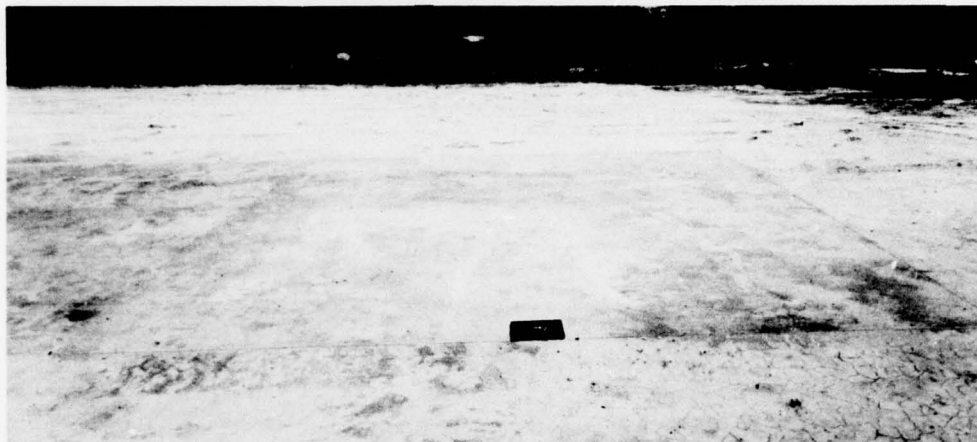
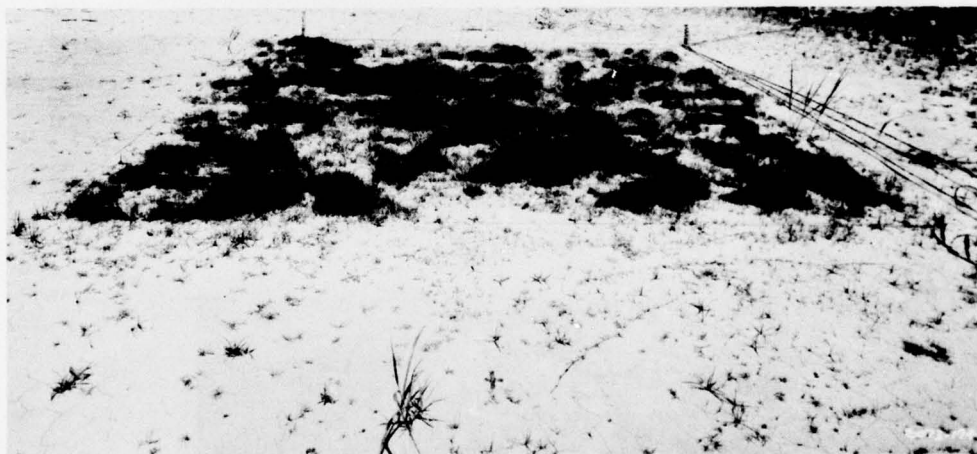
Figure 22. Application of DLR at rate of  
 $0.041 \text{ l/m}^2$  (45 gal/acre) on the flat area (Section Q<sub>3</sub>)

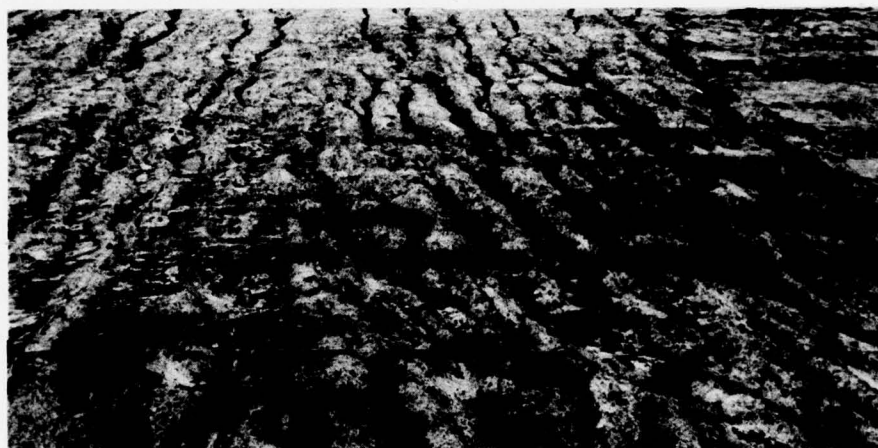
Figure 23. Control plot on the slope (Section P)

14. The control plot on the slope (Figure 23) indicates the results of seeding without using a stabilizer. Very little vegetation has been established in the plot, and rills of 15 to 20 cm (6 to 8 in.) were evident.
